Manhole Inspection Summary

Manhole # S19I1_023MH

Insp Date: **4/18/08 12:35 PM**

Location Address: **2436 harriett av**

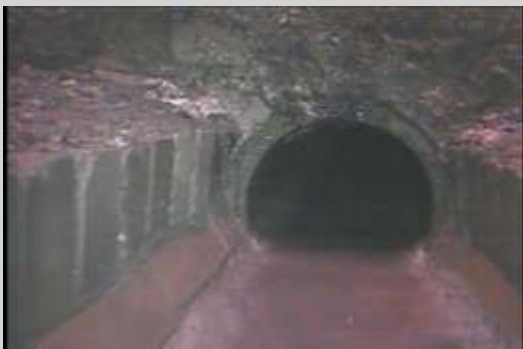
6 O'Clock Inflow

10 in. Circular Gravity Sewer
Pipe In @ 6 O'Clock

Pipe Height: **10.8** (in.) Rod and Bar (Angled)
Pipe Material: **Clay** ☐ Pipe Lined
Invert Depth: **12.70** (ft.) Flow Characteristics: **Slow**
Deposits: ☒ None ☐ Mud ☐ Sludge ☐ Debris ☐ Grease
Silt Depth: **0** (in.) Deposits Extent:
Infiltration: **None** Pipe Seal Cond: **Sound**
